AIRFIELD DAMAGE RECOVERY TECHNIQUES OF
18th ENGINEER BRIGADE IN EUROPE (1811)

LTC Theodore Stroup
CPT David Reed
George M. Hammitt

December 1980

Office, Chief of Engineers, U. S. Army
Washington, D. C. 20314

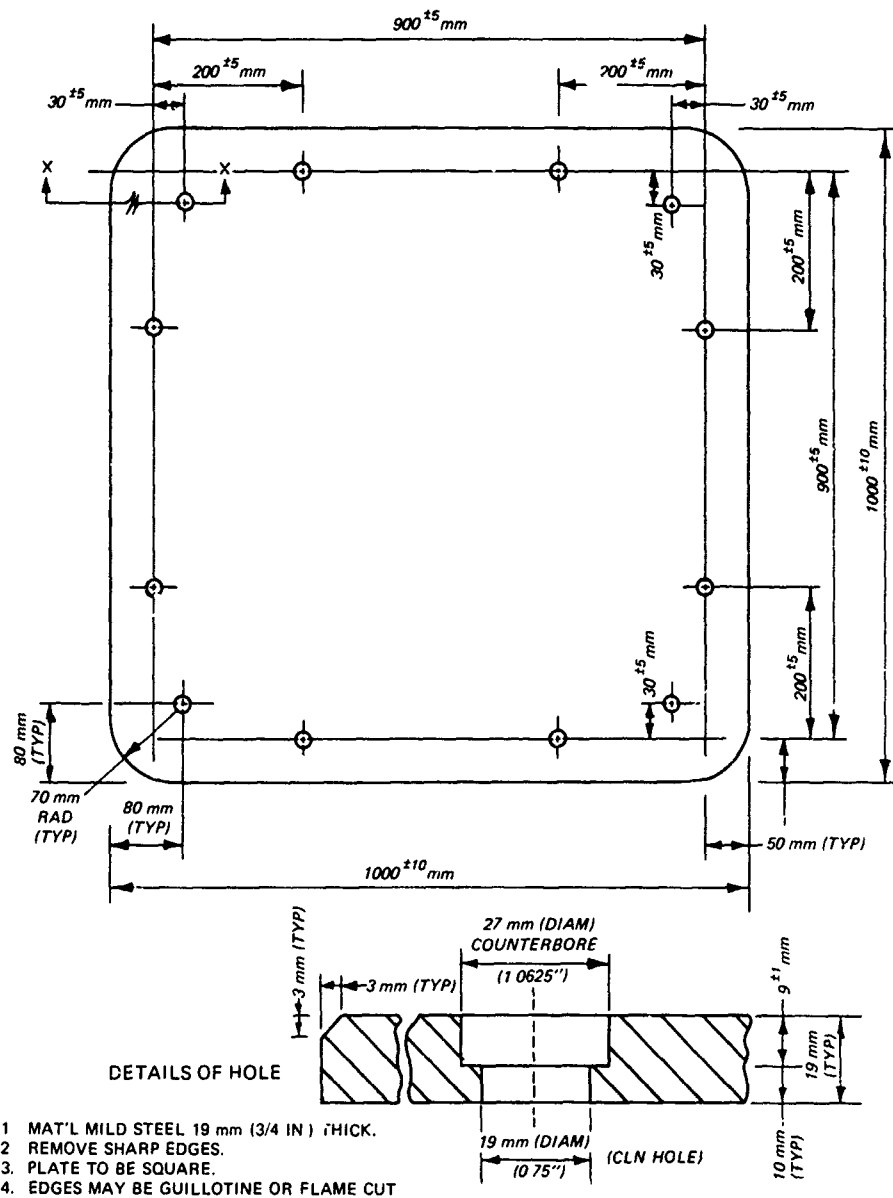
Figure 10

Time estimates given by the British to repair spalls this way are 7 min on a concrete pavement and 10 min on a bituminous pavement. The British also have three sizes of plates for various sized spalls (Figures 10, 11, and 12). Since they have found this method of spall repair to be satisfactory, they advocate its use.

SCAB PLATE-LARGE

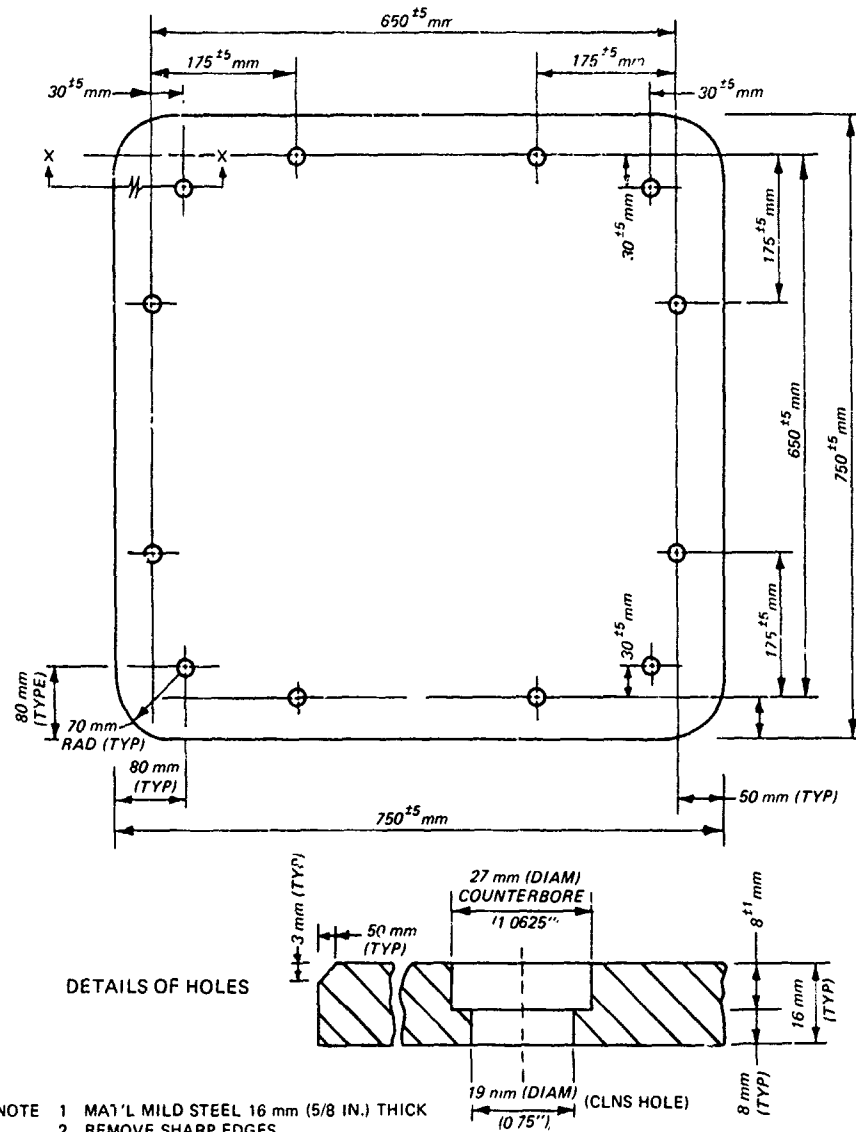
Figure 11

SCAB PLATE-MEDIUM

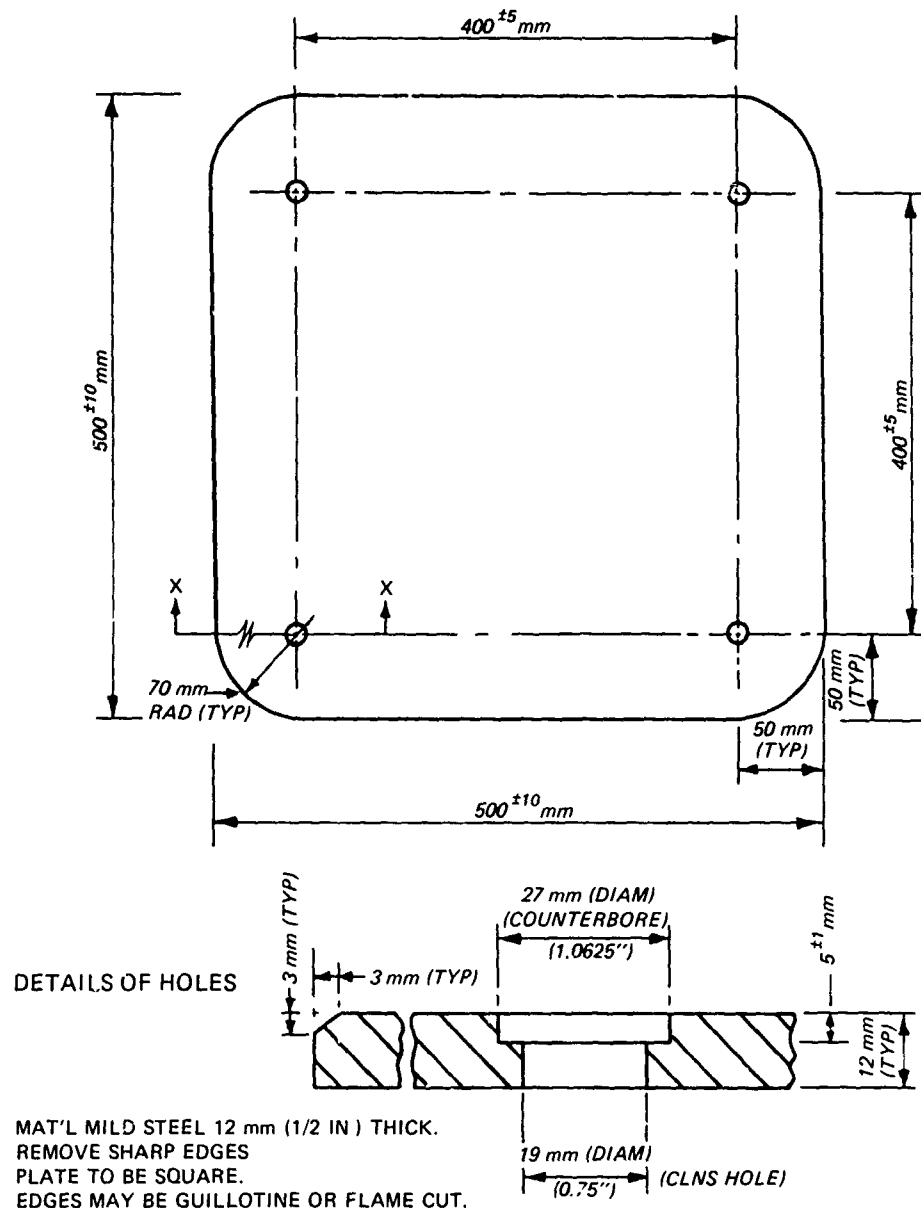
Figure 12

SCAB PLATE-SMALL

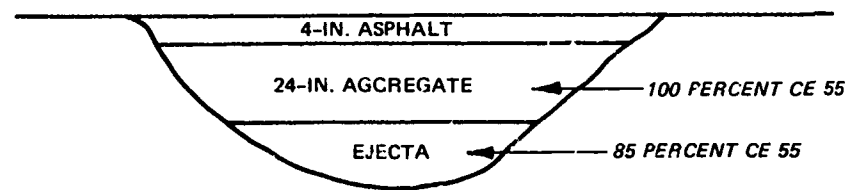
Figure 19

Cross Section of Completed Crater Repair
with Hot-Mix Asphalt

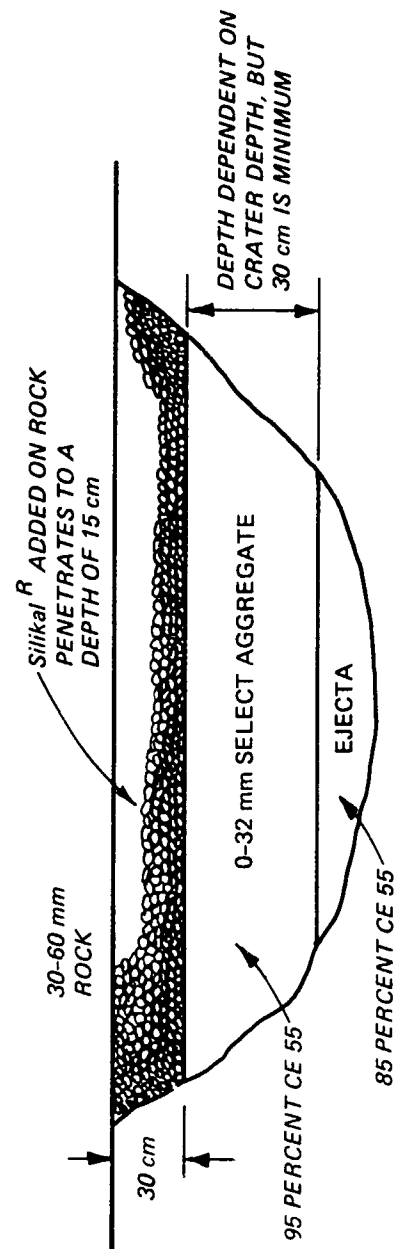
Figure 27

Cross Section of Completed Crater Repair with Silikal^R
